Newsletter of Environmental, Disaster, and Crises Management Strategies

Issue No.11 | November 2018

THE NOVEMBER 24, 2018 SLOPE FAILURES IN PLOMARI TOWN (LESVOS ISLAND, NORTHEAST AEGEAN SEA, GREECE)

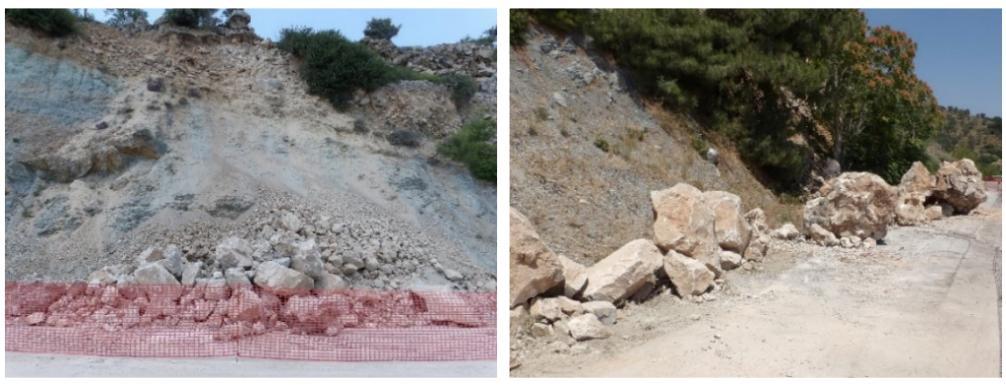
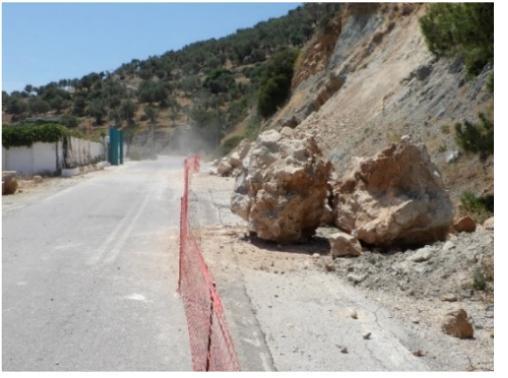
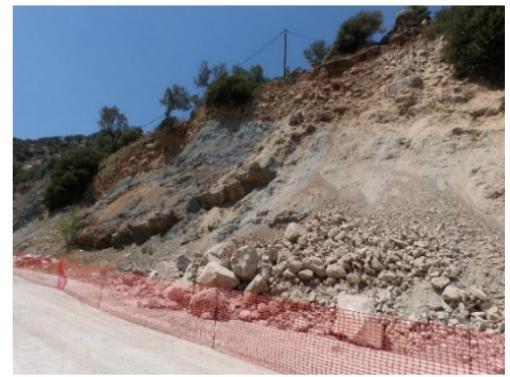
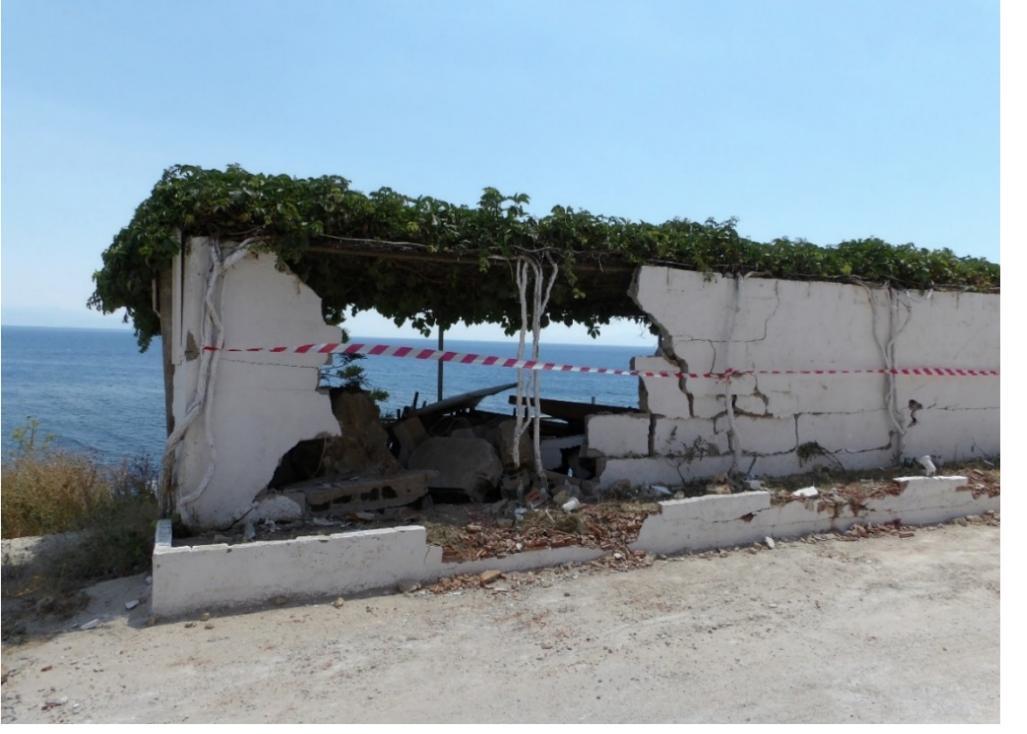
Landslides and rockfalls along artificial slopes of the Plomari-Melinta road network during the 2017 Lesvos earthquake

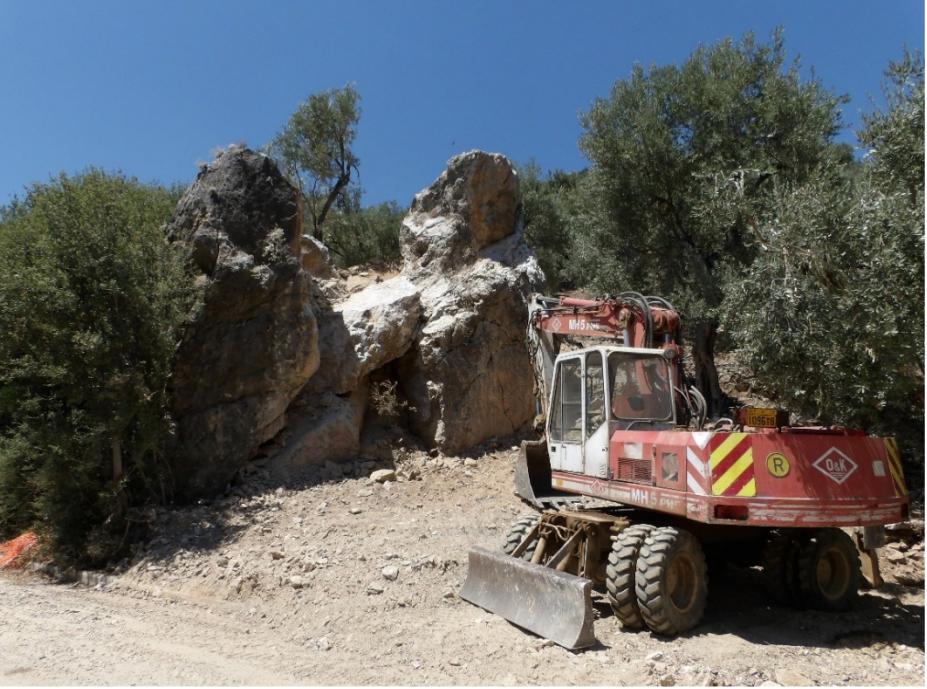
Rockfalls along natural slopes of Palaiochori area during the 2017 Lesvos earthquake

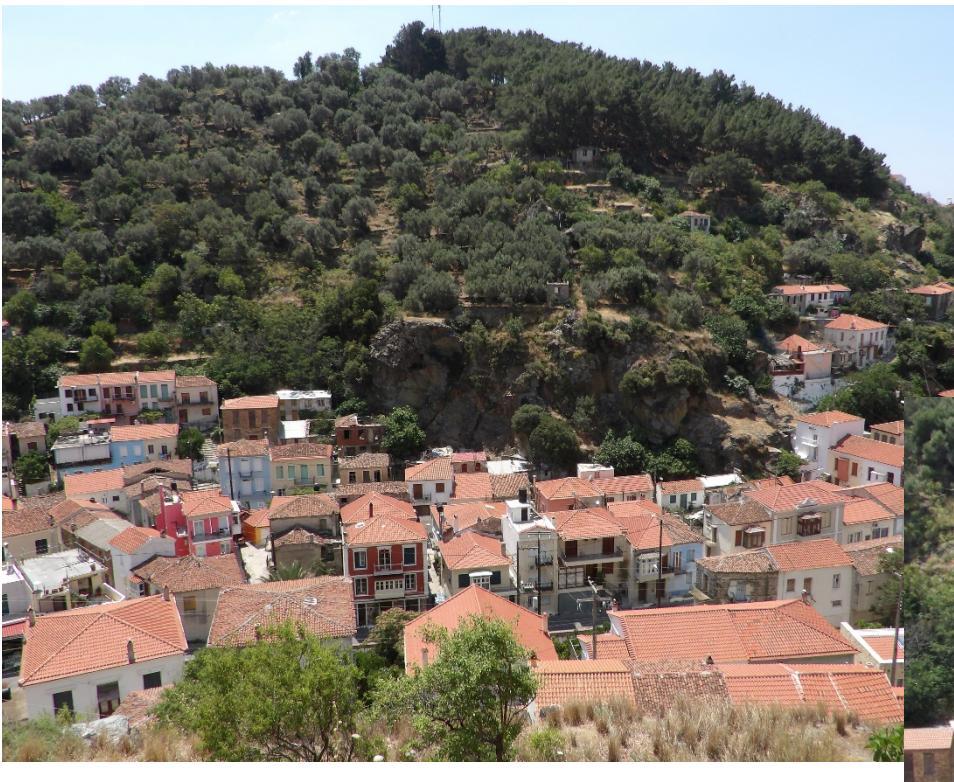
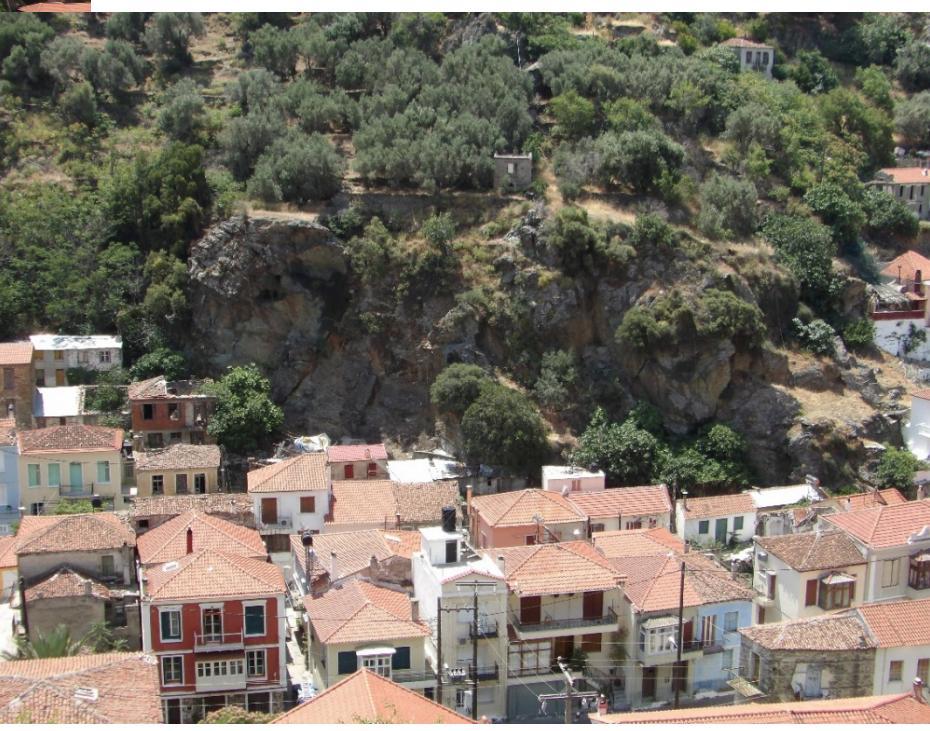
ROCKFALL SITE IN PLOMARI TOWN AFTER THE JUNE 12, 2017 LESVOS EARTHQUAKE

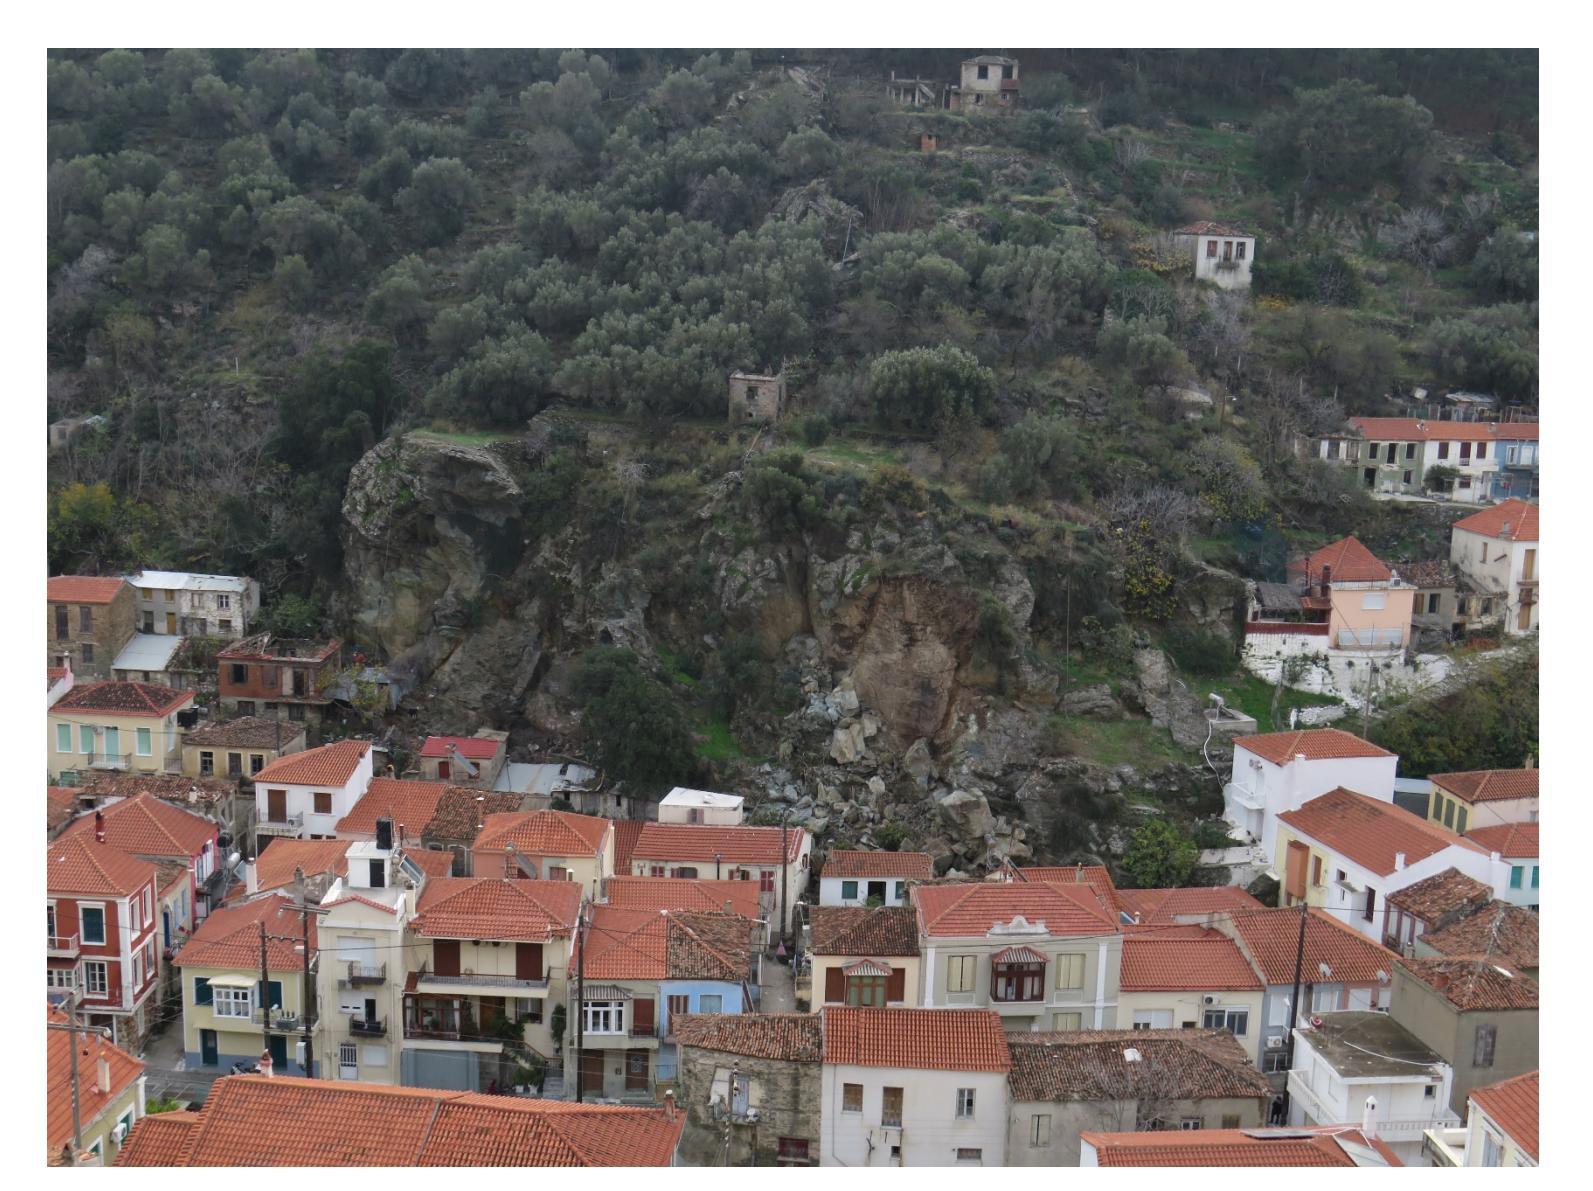
THE NOVEMBER 24, 2018 PLOMARI ROCKFALL

The last episode along this geotechnically unstable zone is the generation of the 2018 rockfalls, which resulted in damage to buildings founded on the base of the slope, fortunately without casualties. Green schists blocks were detached from the steep slope and moved downward toward the adjacent buildings resulting in destruction.

The induced damage affected non-structural and structural elements of masonry buildings and structural elements of a reinforced concrete building. More specifically, detachment of large pieces of plaster from the load-bearing walls and destruction of the roof were observed in the first category and partial collapse of the infill walls and heavy damage of columns in the second category attributed to crushing with the rockfall materials.

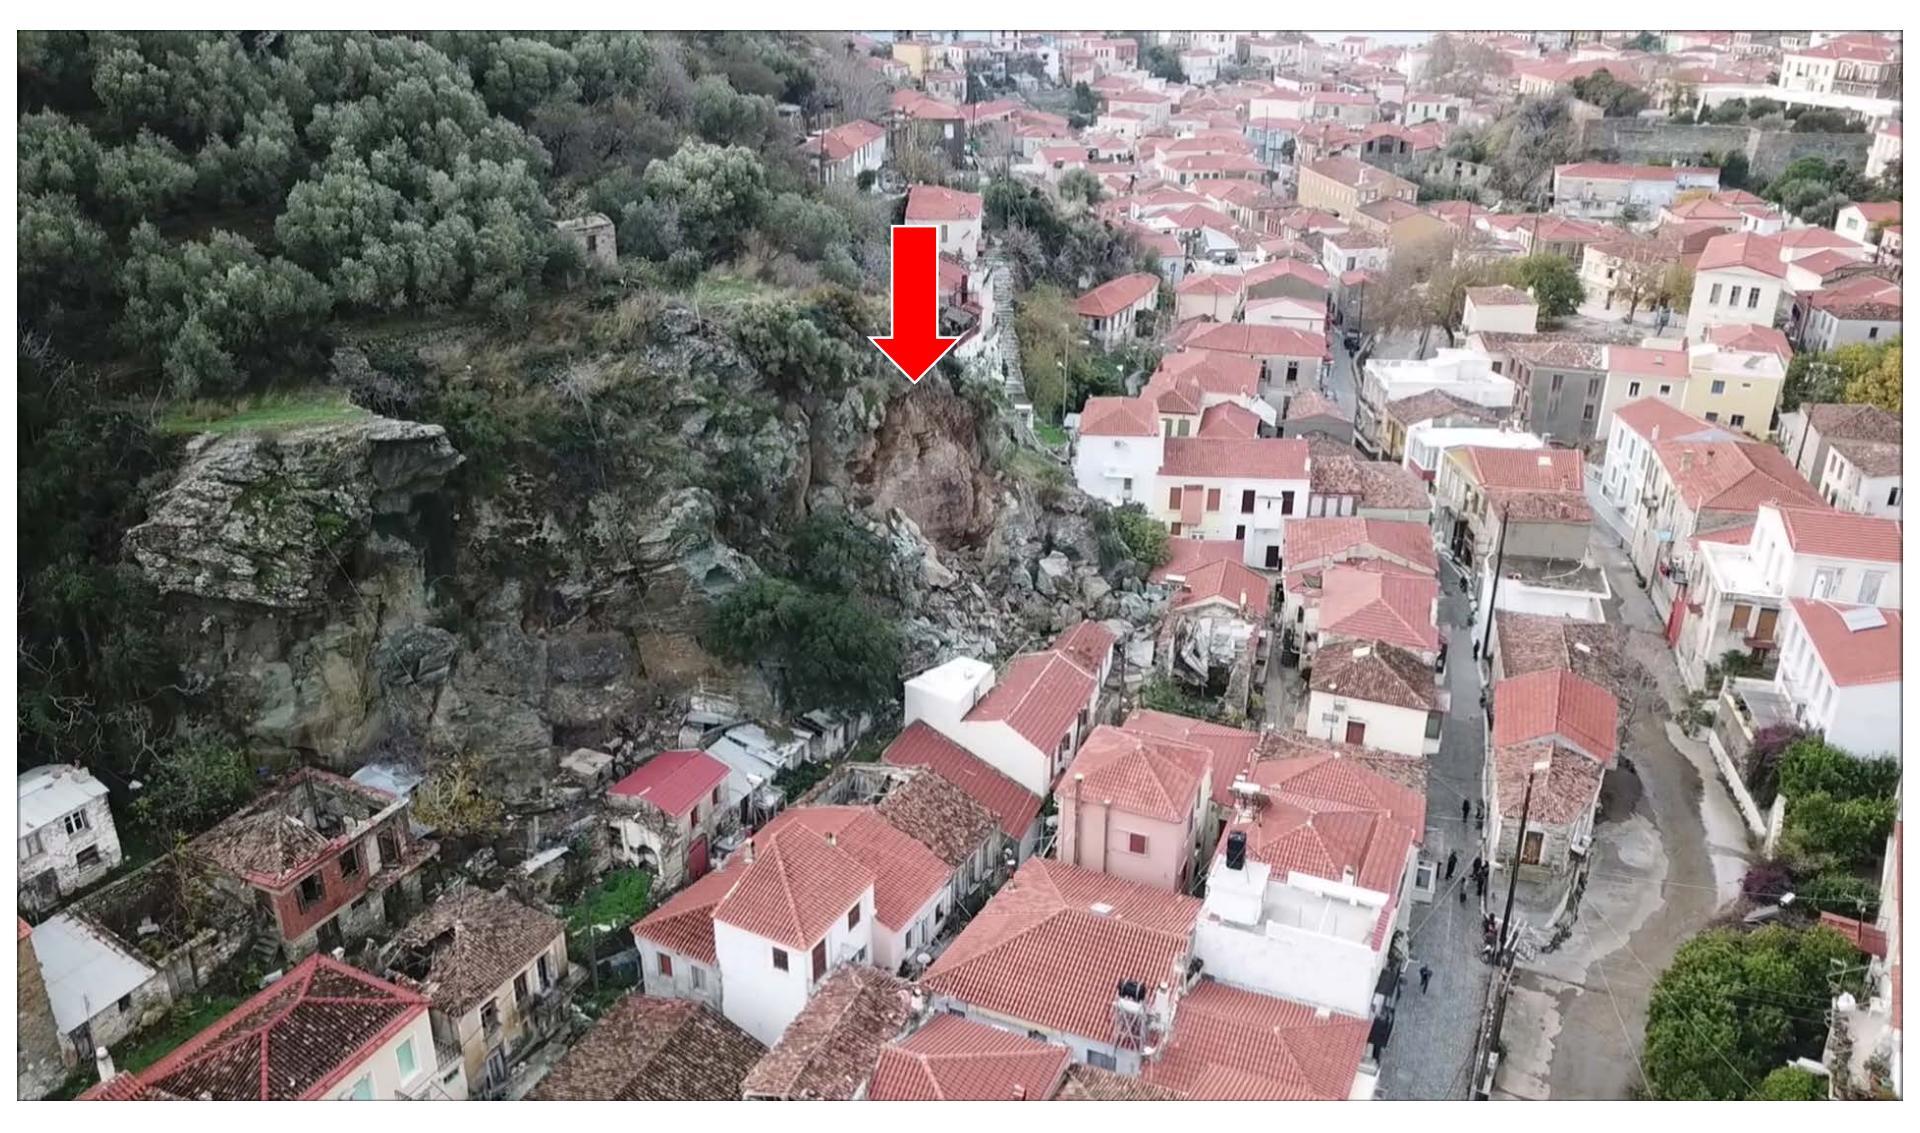
EXPOSED SURFACES OF JOINT WALLS AFTER PLOMARI ROCKFALLS MAIN DETACHMENT AND SLIDING PLANE

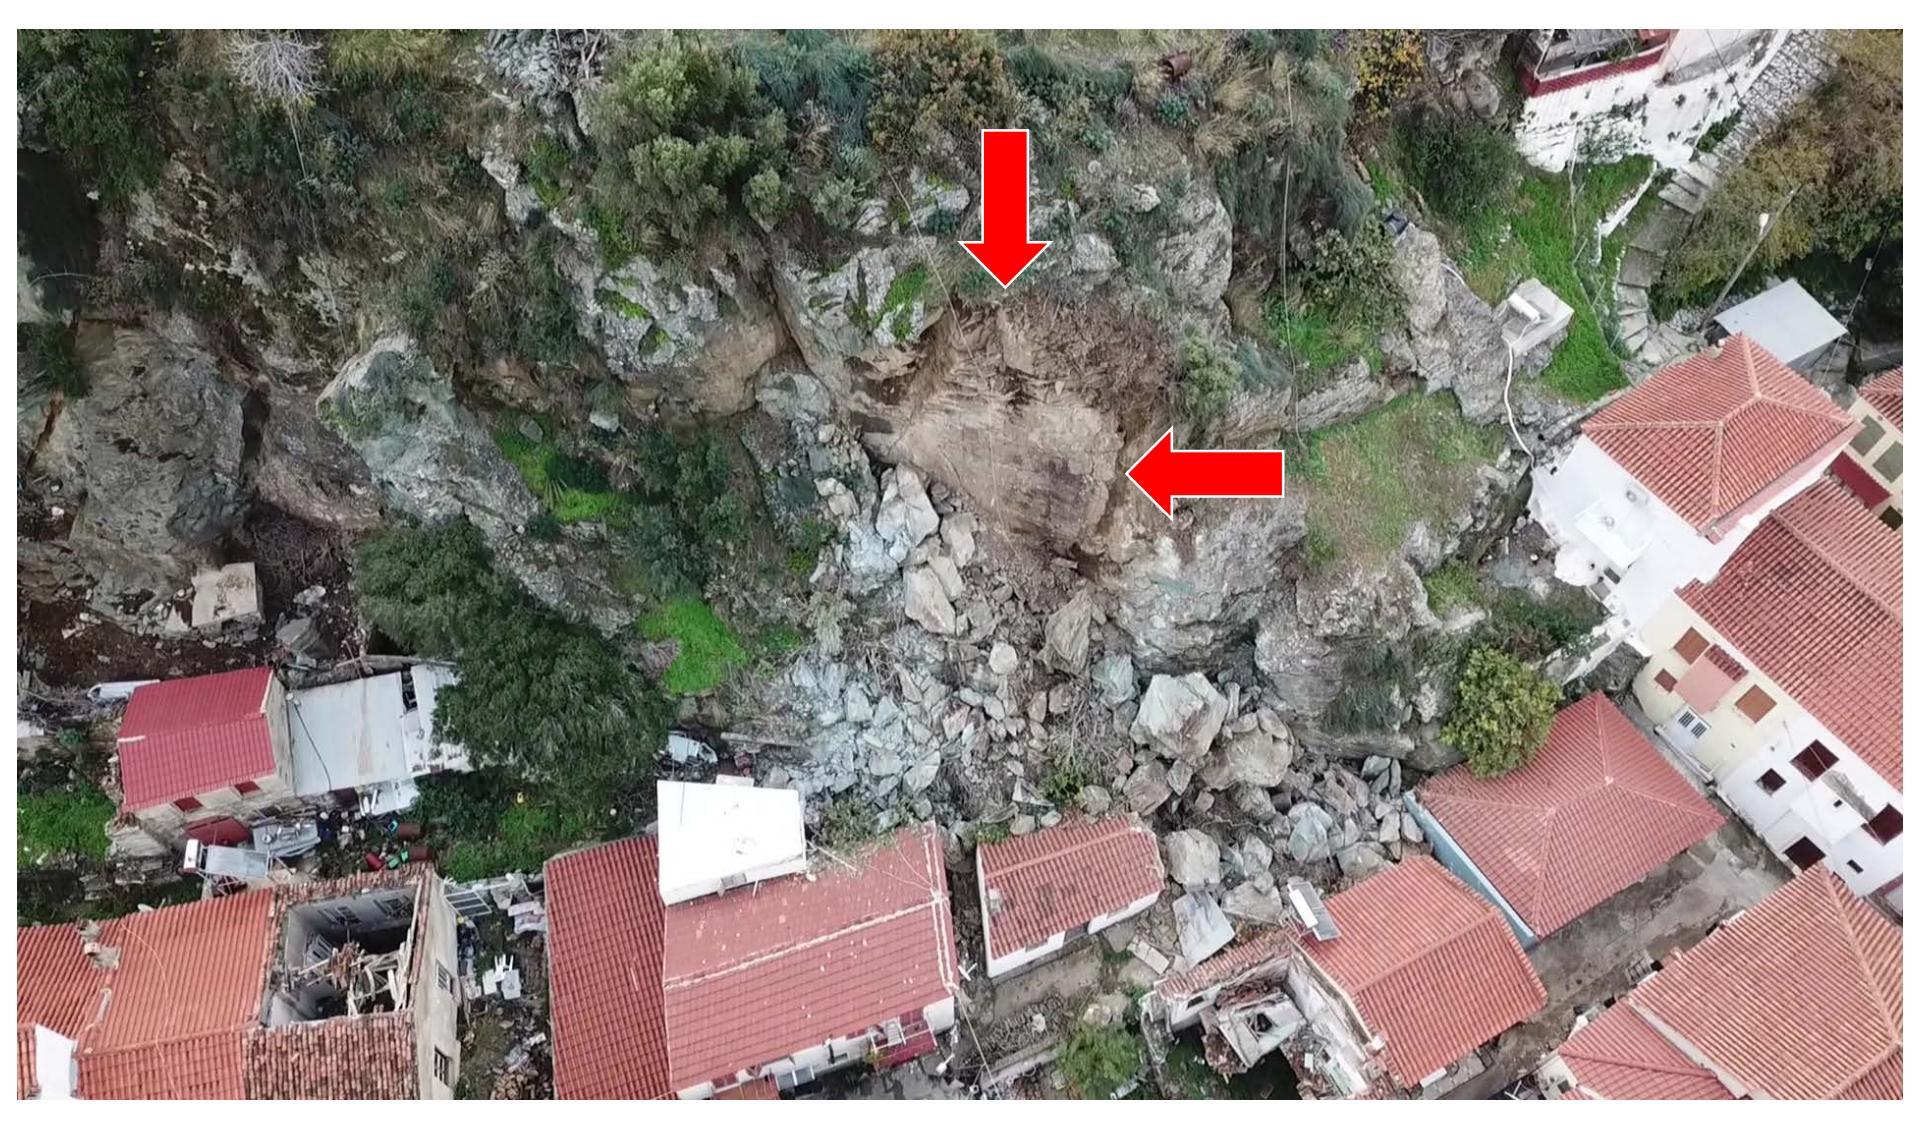
EXPOSED SURFACES OF JOINT WALLS AFTER PLOMARI ROCKFALLS MAIN DETACHMENT AND SLIDING PLANE

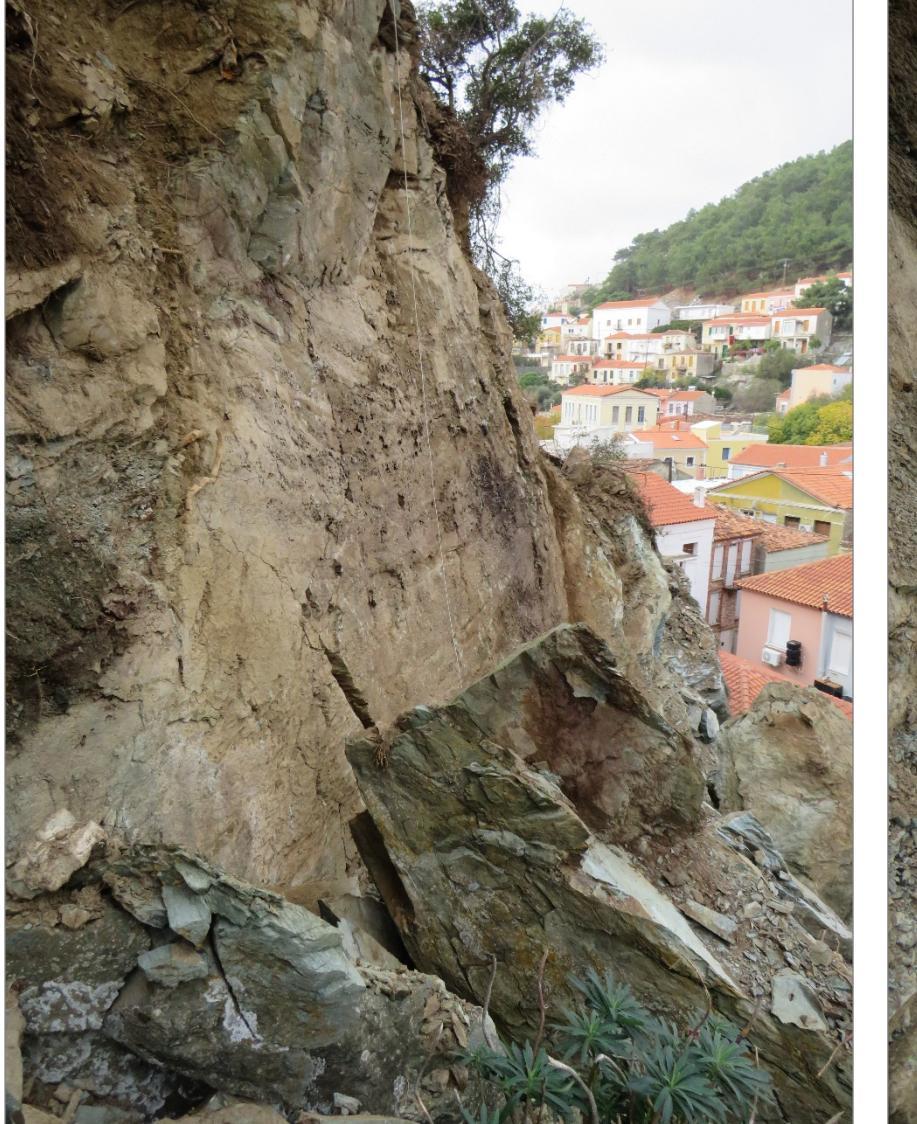
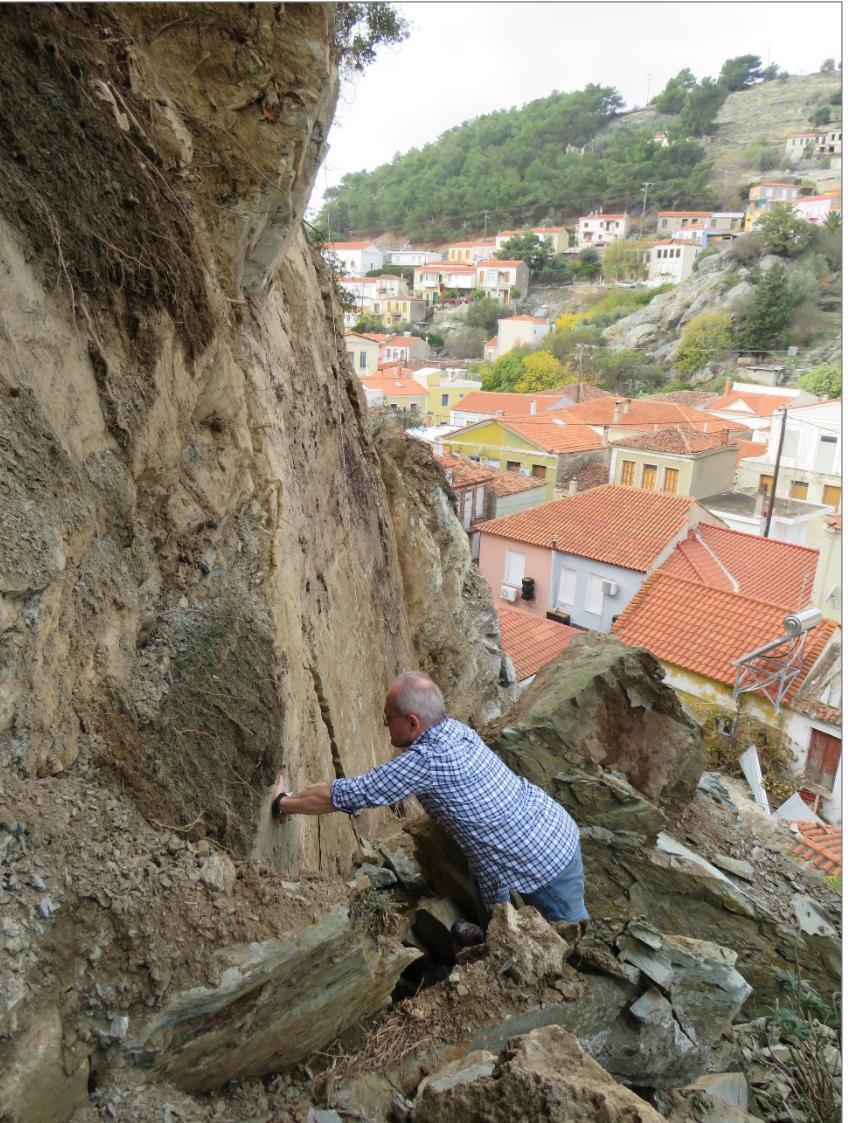
EXPOSED SURFACES OF JOINT WALLS AFTER PLOMARI ROCKFALLS MAIN DETACHMENT AND SLIDING PLANE

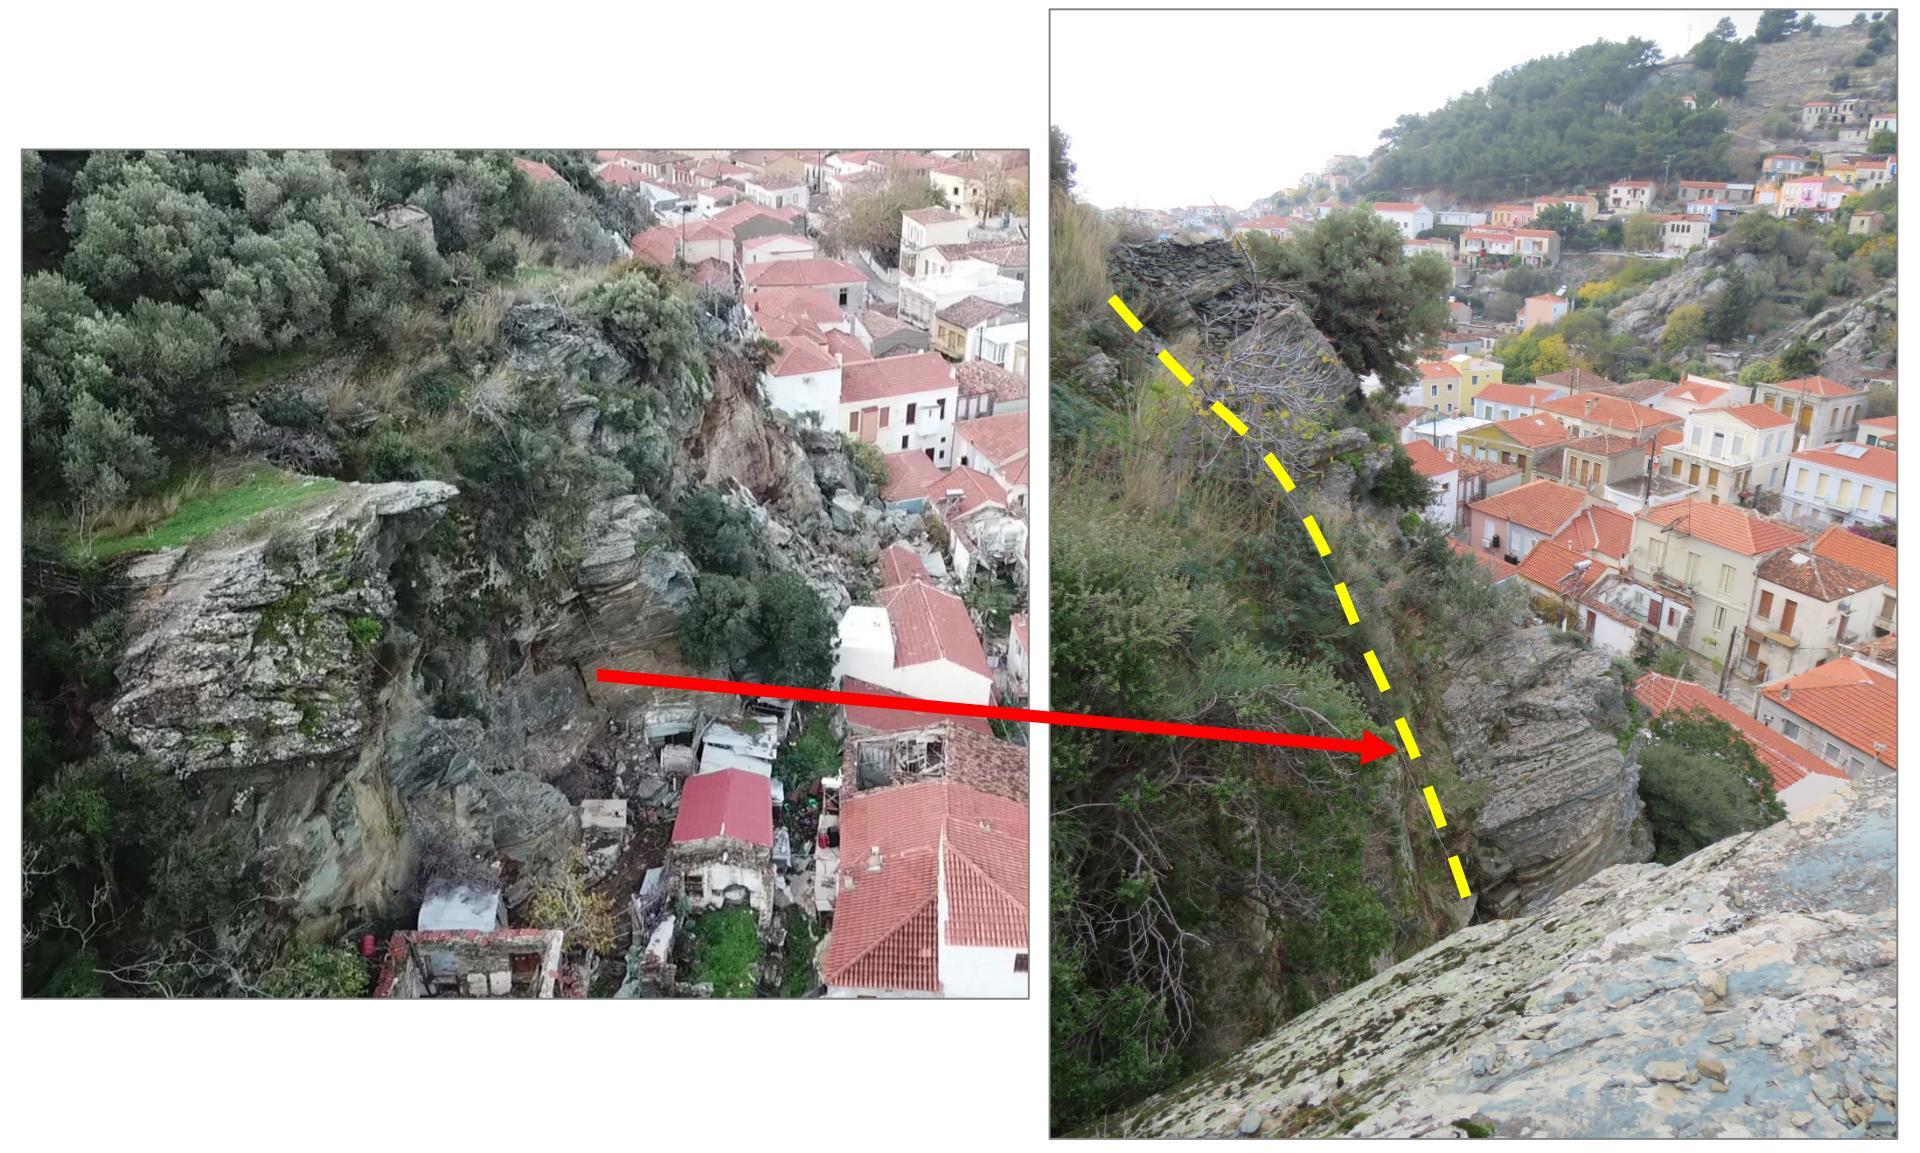
MAIN DETACHMENT SURFACE NOT EXPOSED AFTER THE PLOMARI ROCKFALLS POSSIBLE FUTURE DETACHMENT PLANES

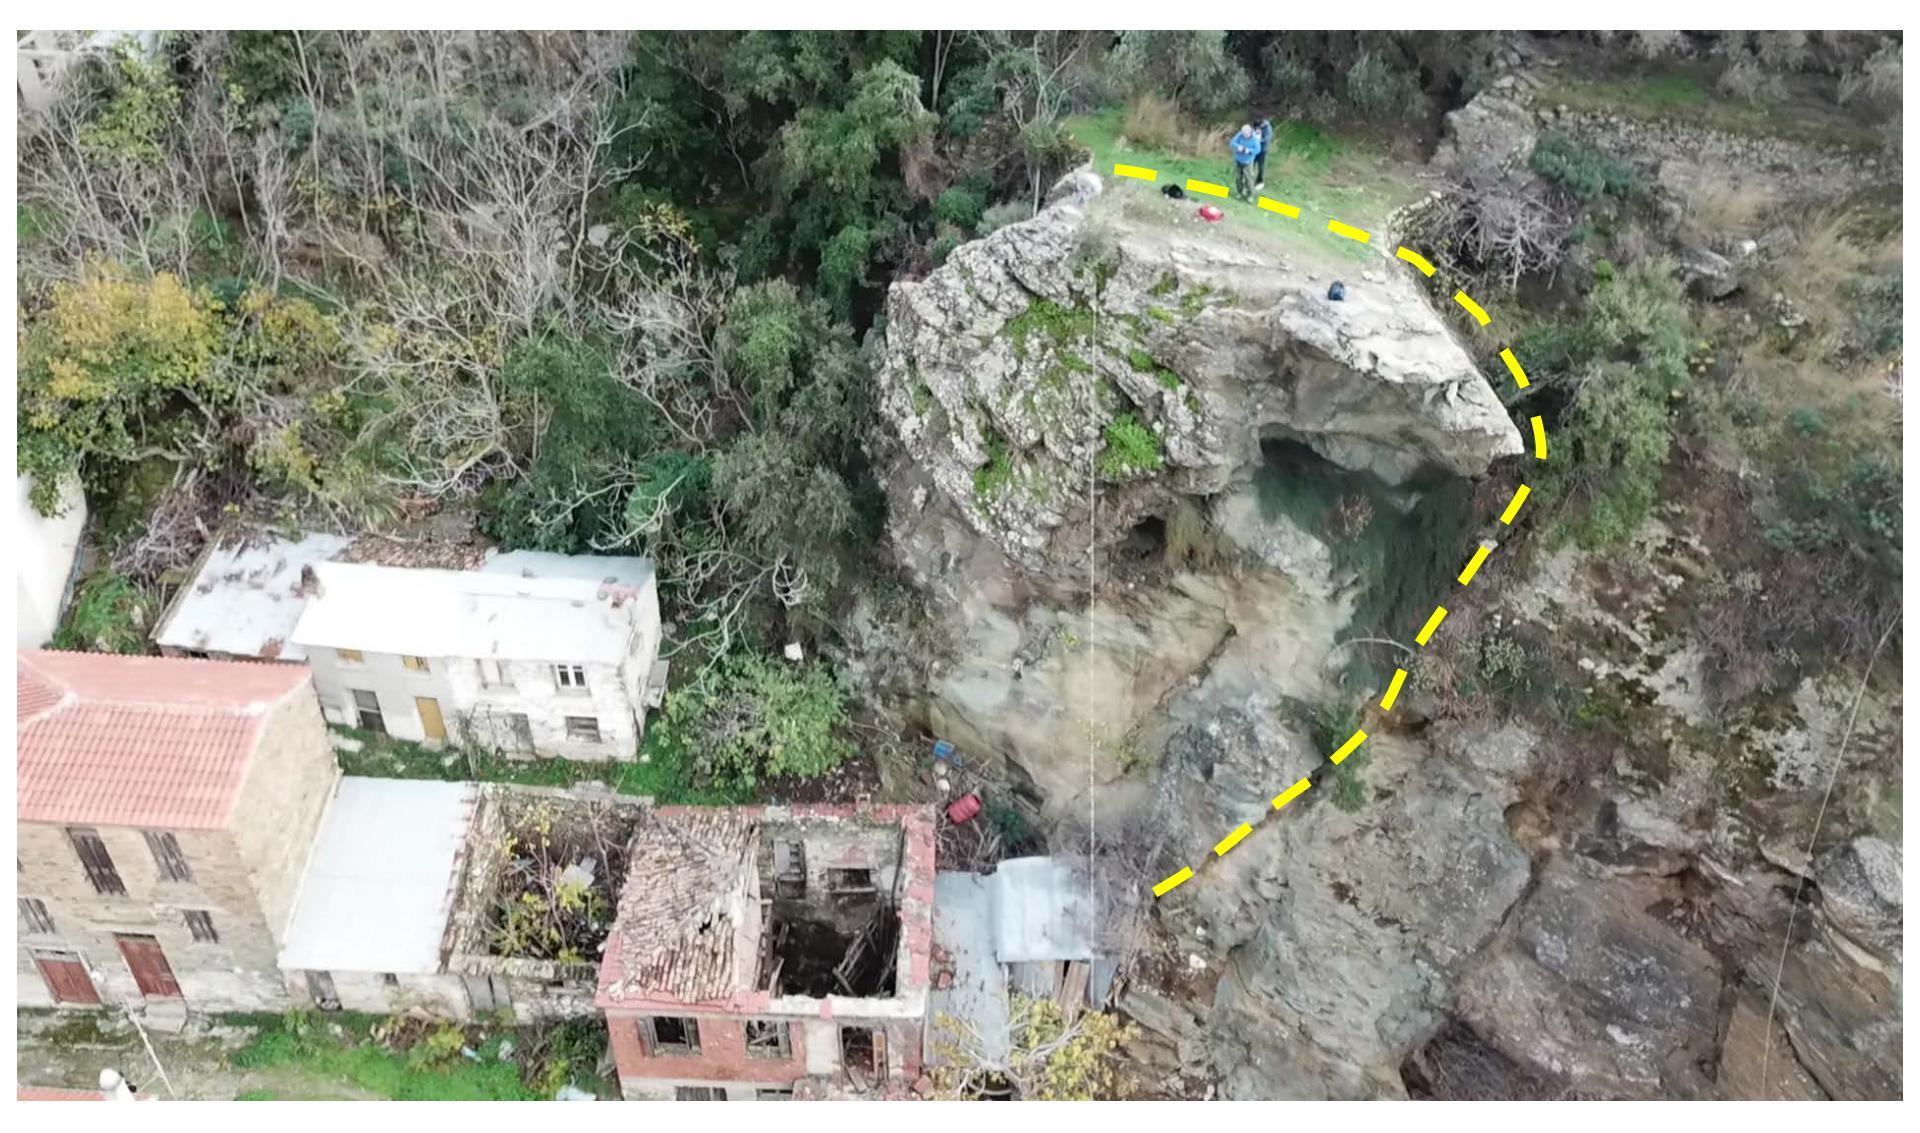
MAIN JOINTS PARTIALLY FILLED WITH LARGE FRAGMENTS AND MATRIX POSSIBLE FUTURE DETACHMENT PLANES

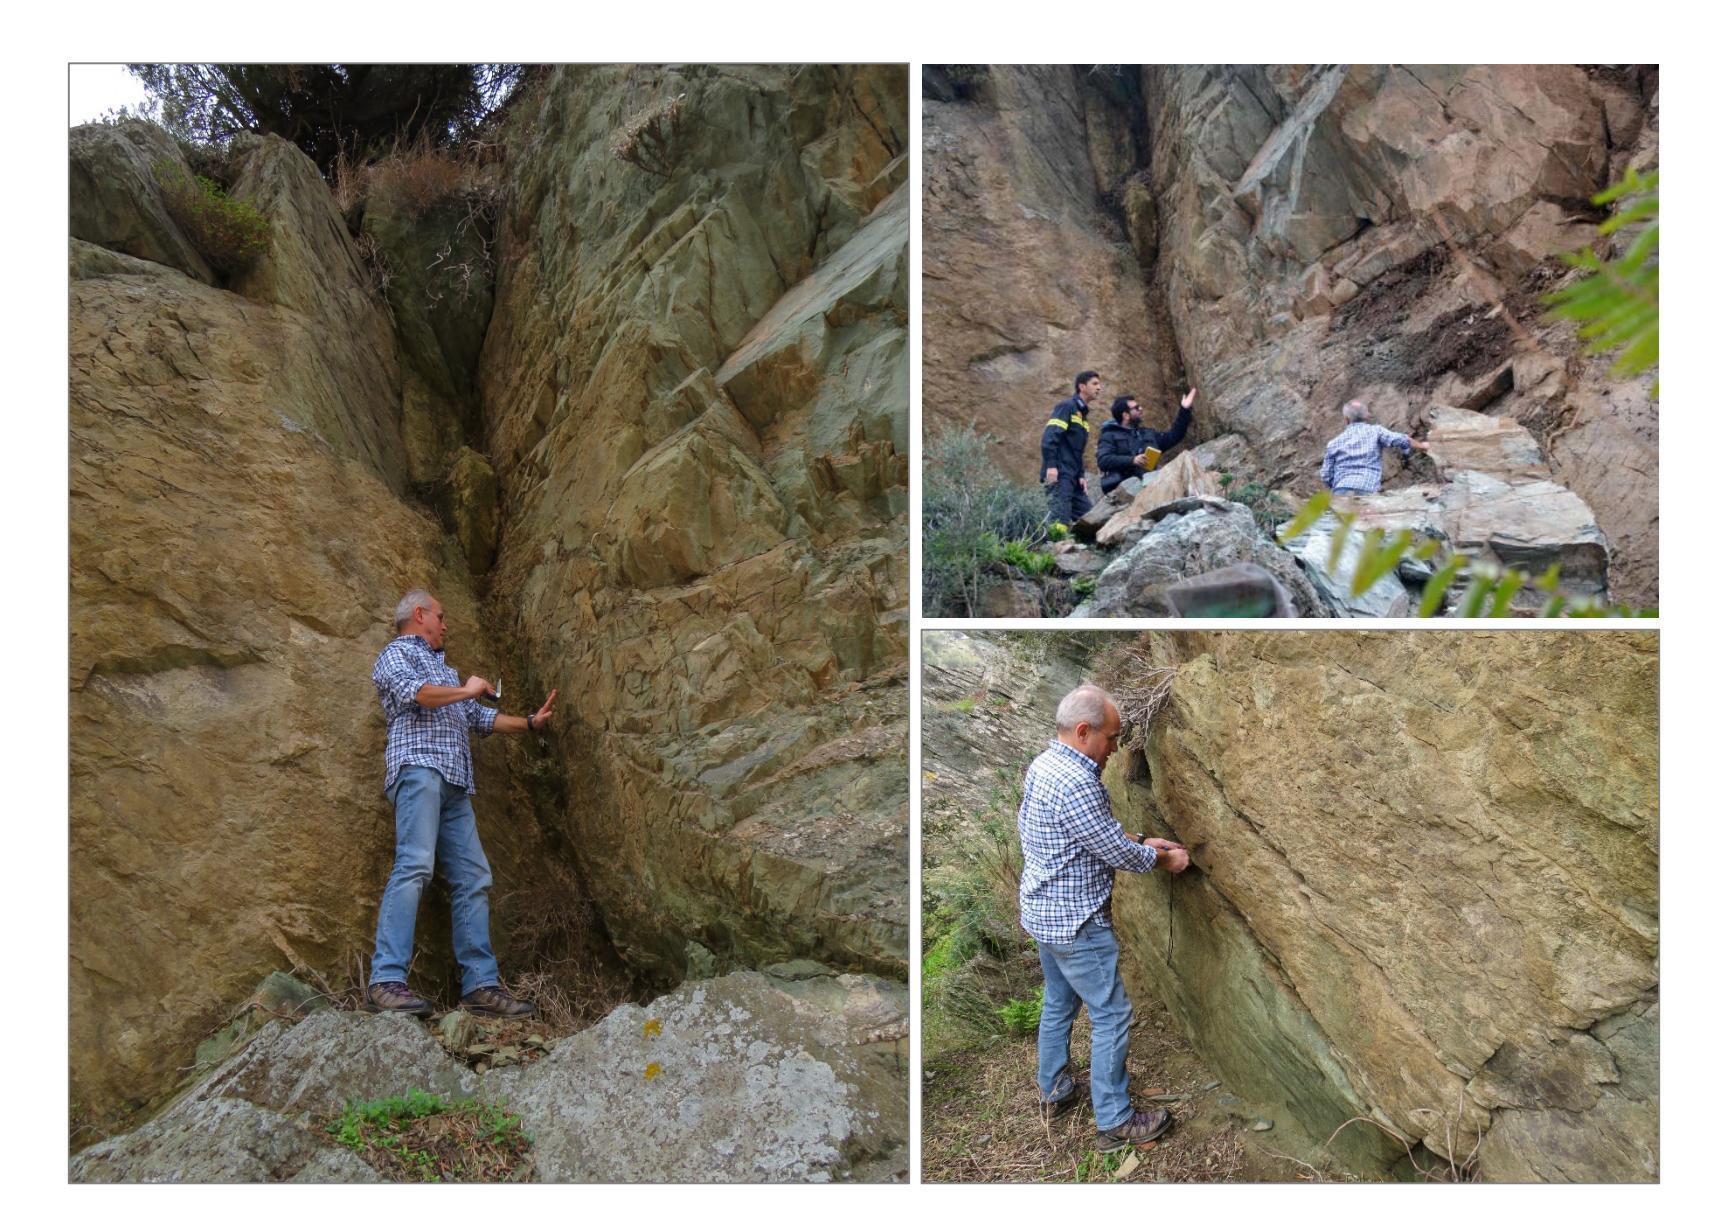
SECONDARY JOINTS AFFECTING THE STABILITY OF THE SLOPE

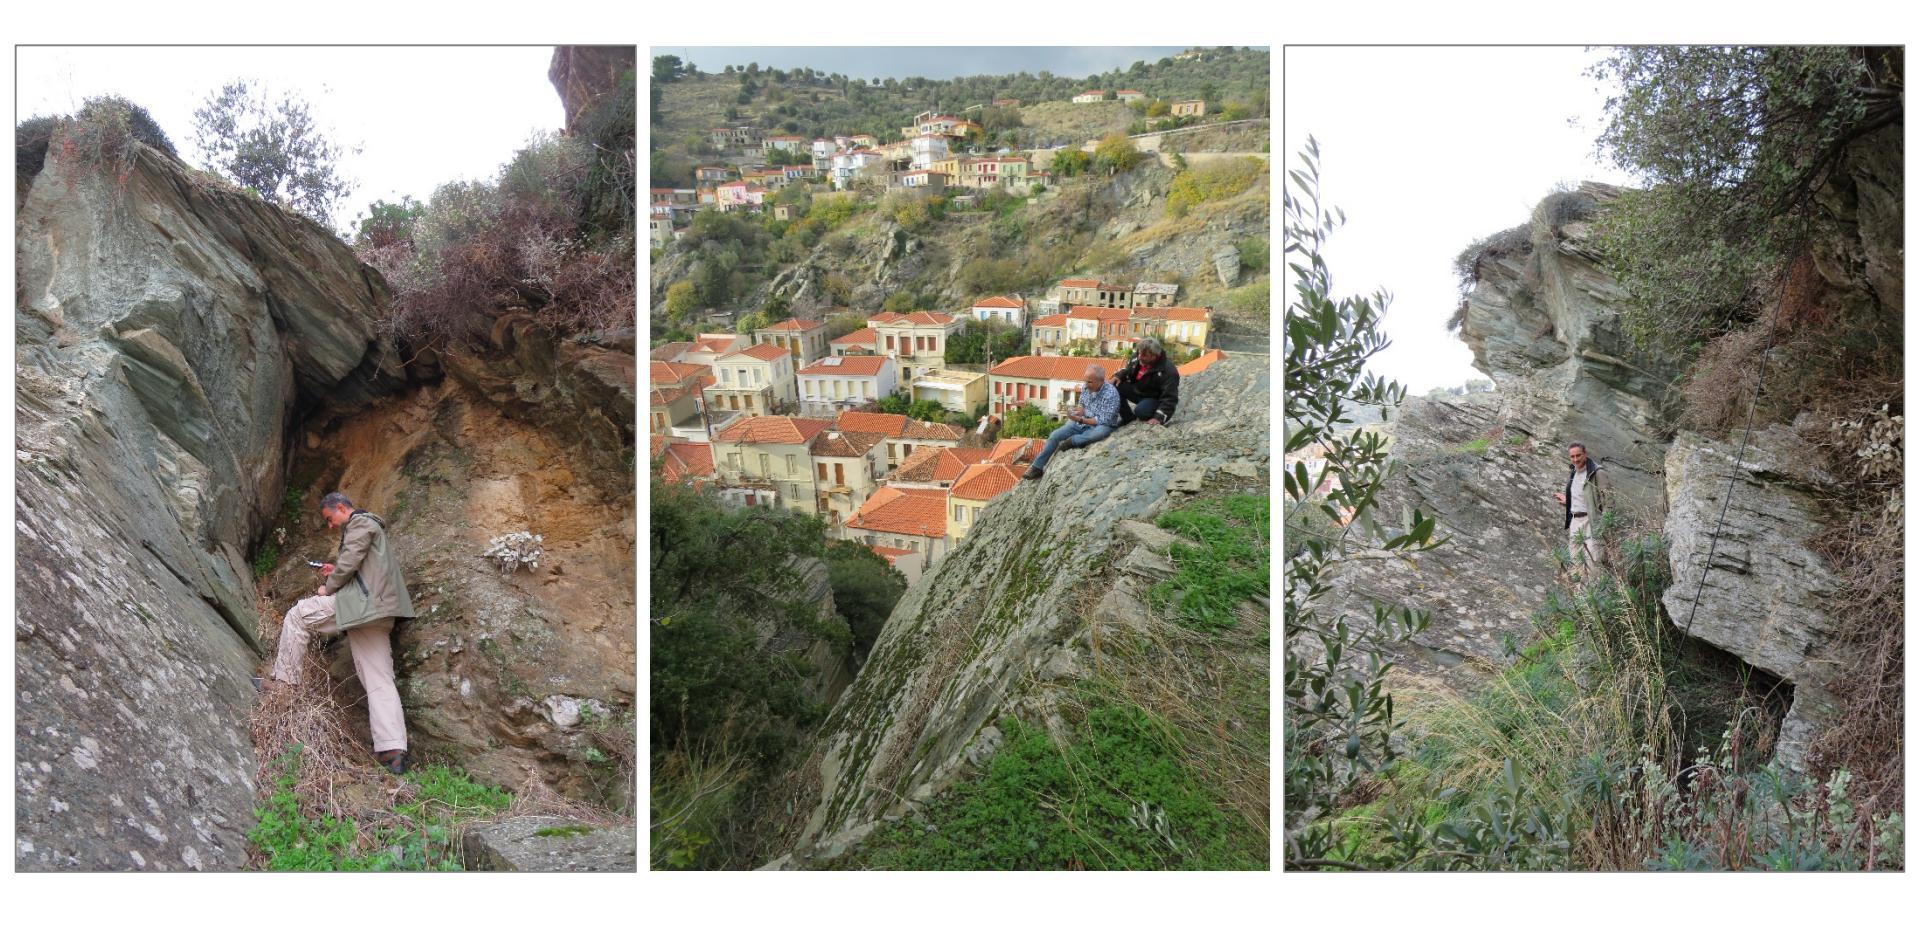
SECONDARY JOINTS AFFECTING THE STABILITY OF THE SLOPE

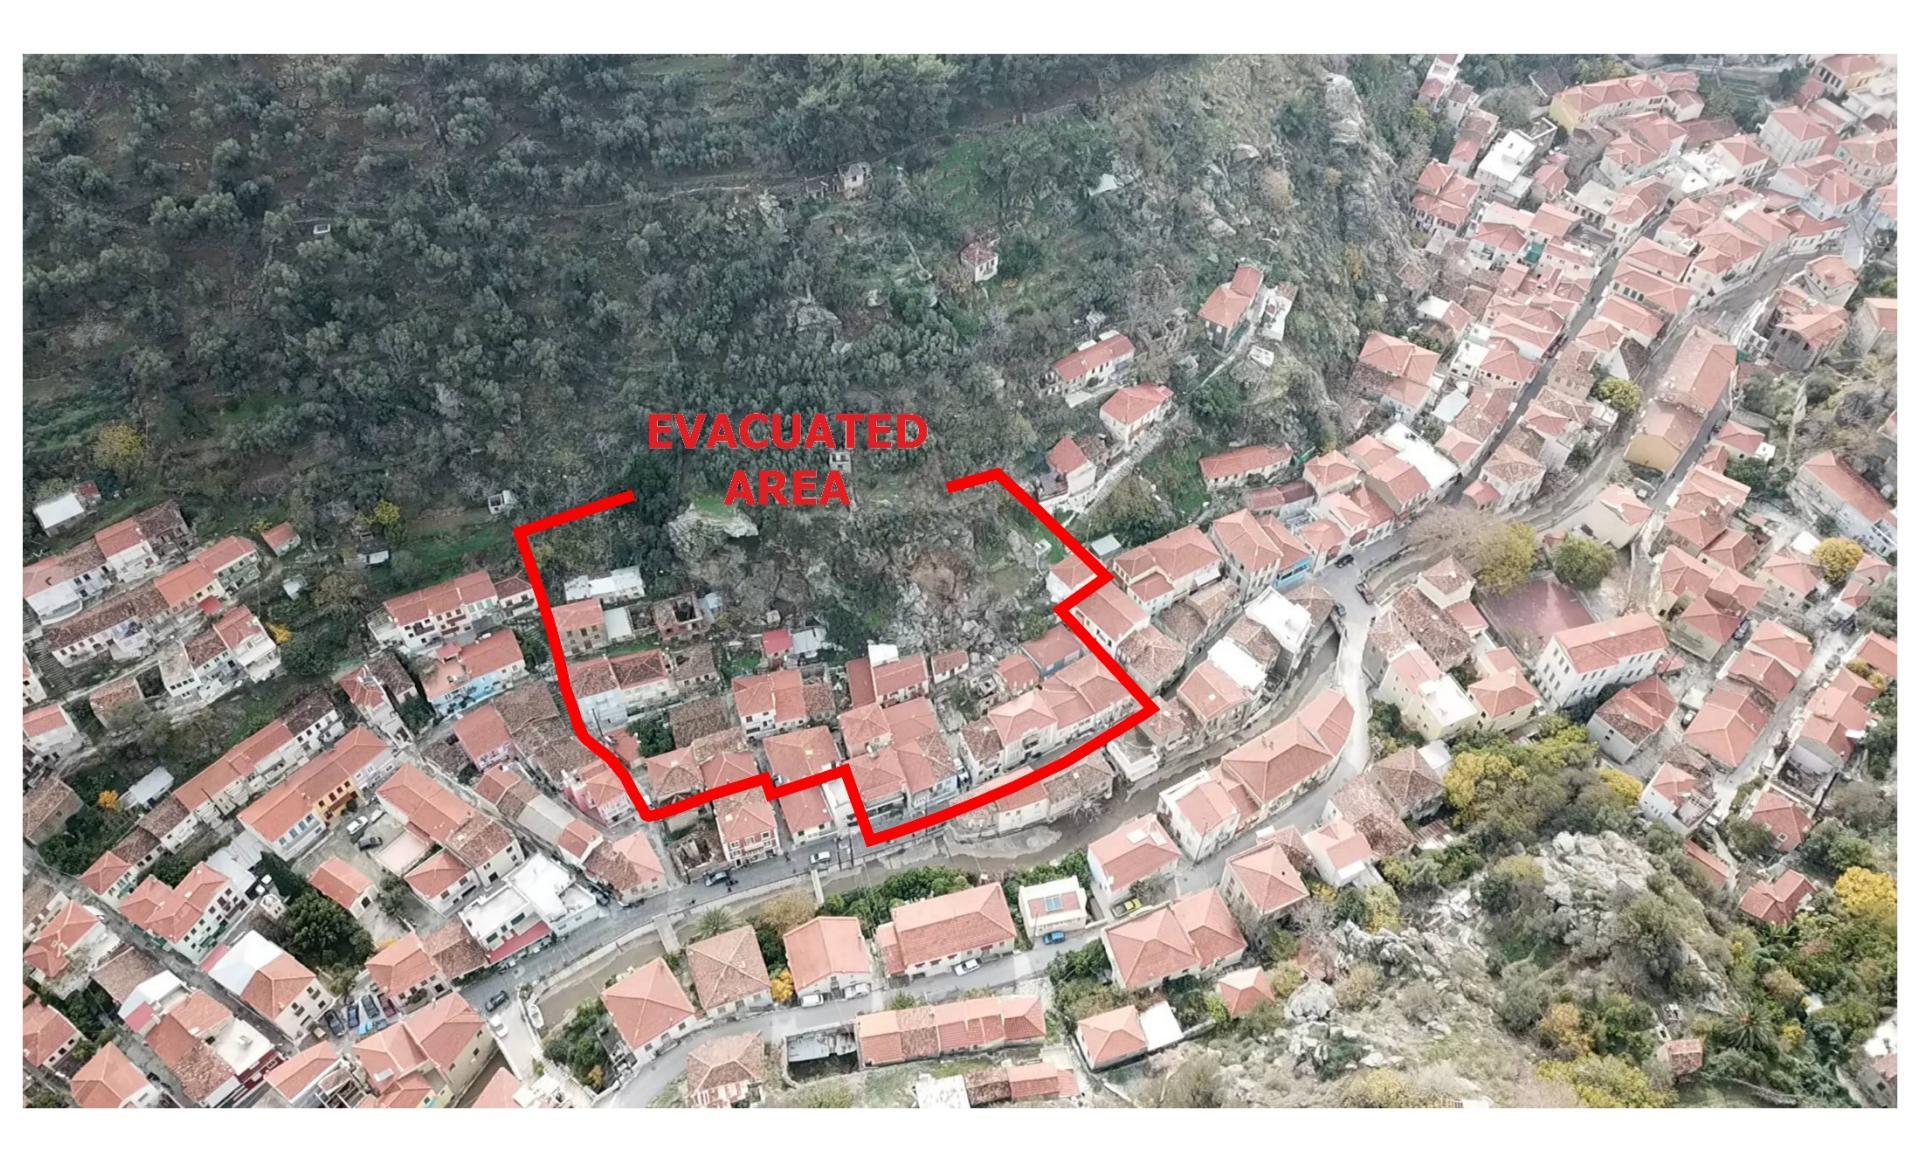
PROPOSED MEASURES FOR POPULATION PROTECTION

Based on all available morphological, geological, geotechnical, seismological and meteorological data, the scientific team proposed the evacuation of buildings close to the steep slope until the completion of the protection measures adopted for landslide risk assessment and mitigation.
