Newsletter of Environmental, Disaster, and Crises Management Strategies

Issue No.11 | November 2018

THE NOVEMBER 24, 2018 SLOPE FAILURES IN PLOMARI TOWN (LESVOS ISLAND, NORTHEAST AEGEAN SEA, GREECE)

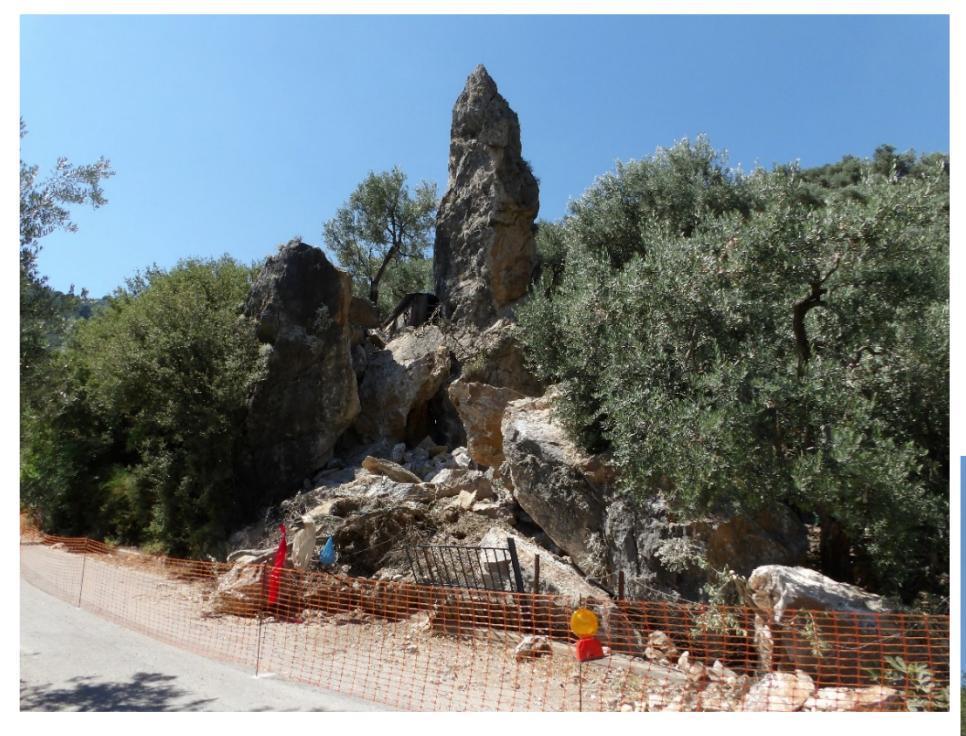
SLOPE FAILURES IN PLOMARI AREA DURING THE 2017 LESVOS EARTHQUAKE

Rockfalls along natural slopes of Palaiochori area during the 2017 Lesvos earthquake

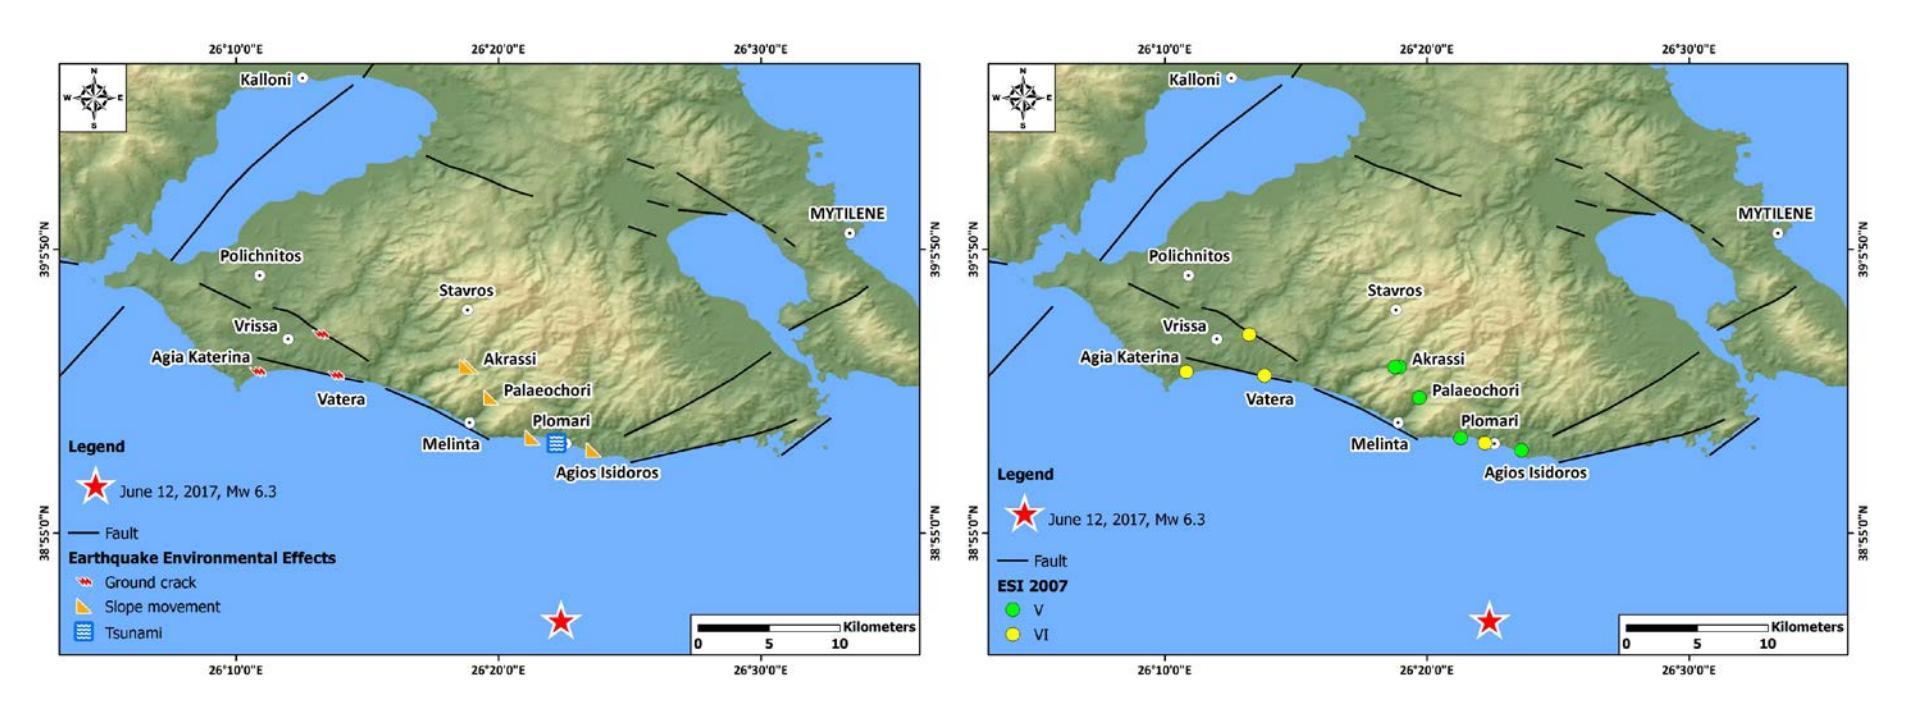
SLOPE FAILURES INDUCED BY THE 2017 LESVOS EARTHQUAKE

Plomari is located within the zone that suffered significant impact from the 2017 Lesvos earthquake. This zone comprised earthquake environmental effects induced by the 2017 Lesvos earthquake that included ground cracks in the western part of the affected area (Vatera, Agia Katerina, along the Polychnitos fault) and slope movements including landslides and rockfalls in the eastern part of the affected area (Palaeochori, along the road from Plomari to Melinta, Akrassi, Agios Isidoros) and damage to buildings including non-structural and structural damage.

Despite the fact that Plomari was within the meizoseismal area with already geotechnically unstable areas, no slope failures were observed within its residential area.

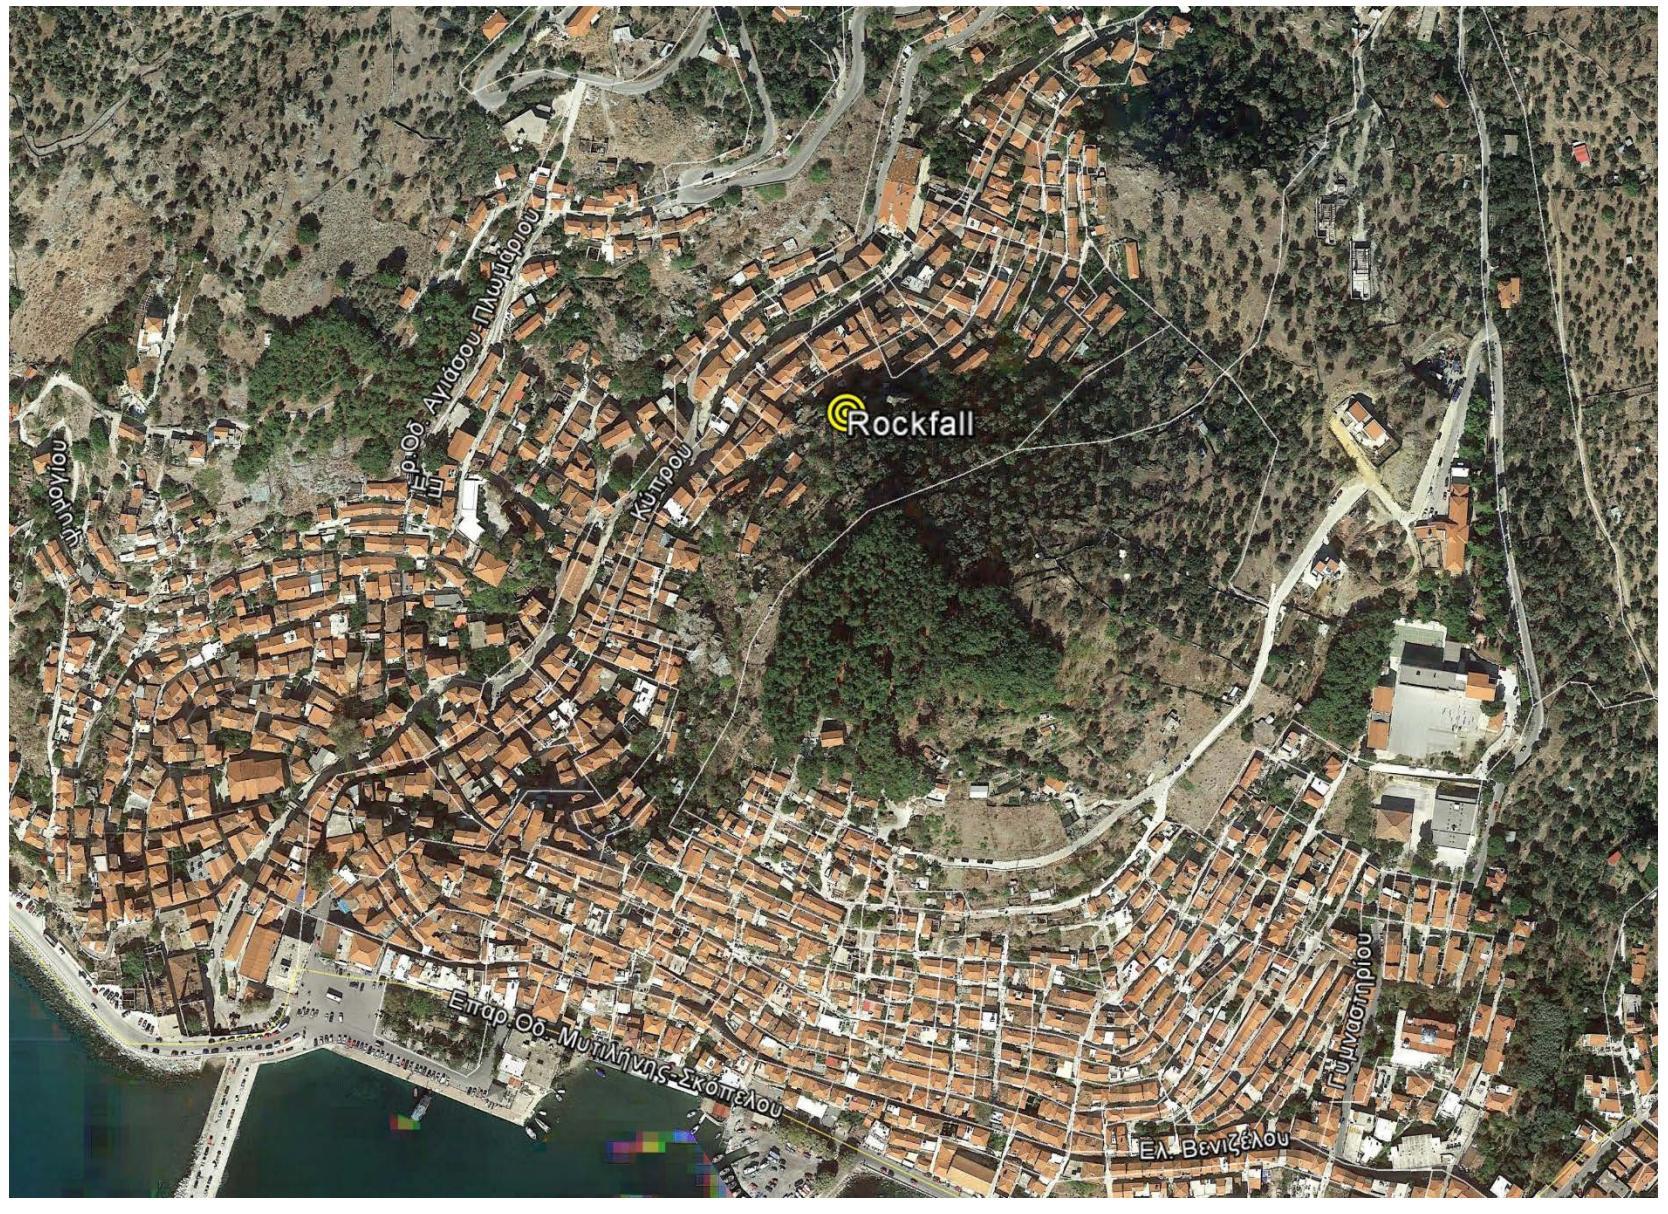
ROCKFALL SITE IN PLOMARI TOWN

On November 24, 2018 a large rockfall was generated in the central part of Plomari town, located in the southeastern part of Lesvos Island (Northeastern Aegean Sea, Greece). The rockfall occurred along a steep slope in the western part of Profitis Ilias hill, which is composed of Permian-Triassic schists. This steep slope is characterized by a great variety of joints with different characteristics [length, continuity, separation, surface characteristics (smoothness and waviness), condition of the discontinuity] that forms a geotechnically unstable zone with generation of slope failures during historical and recent times based on various sources including reports and eyewitnesses.

The last episode along this geotechnically unstable zone is the generation of the 2018 rockfalls, which resulted in damage to buildings founded on the base of the slope, fortunately without casualties. Green schists blocks were detached from the steep slope and moved downward toward the adjacent buildings resulting in destruction.

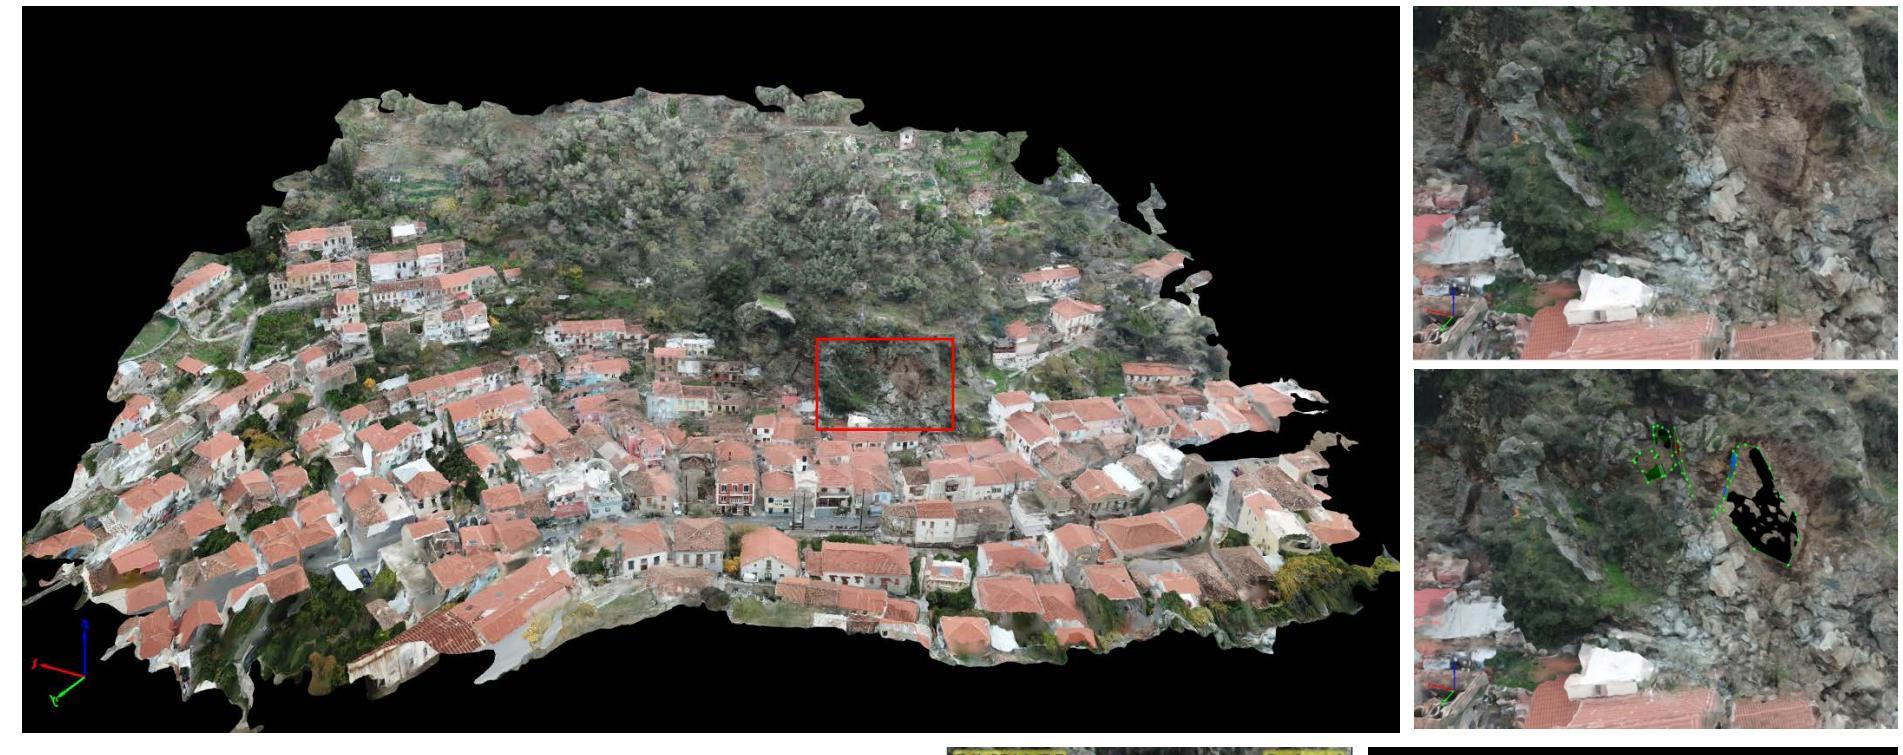
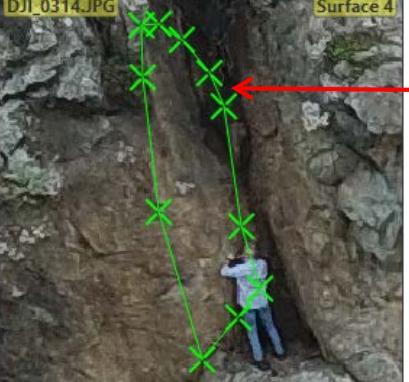
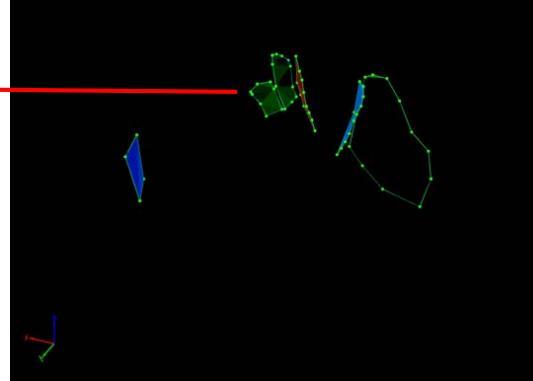
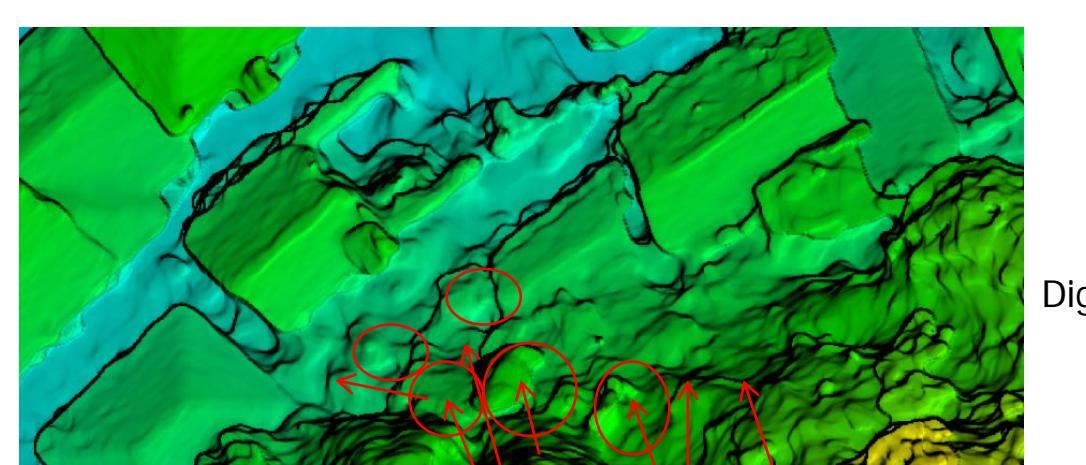
MAPPING OF THE SLOPE FAILURE SITE WITH UNMANNED AERIAL VEHICLE

- 3D MODEL
- 3D TECTONIC MAPPING
- FIELD MEASUREMENTS
- 3D FRACTURE GEOMETRY
